GENERAL LAYOUT GUSTAVUS

Gustavus Ferry Terminal

Owner: State of Alaska

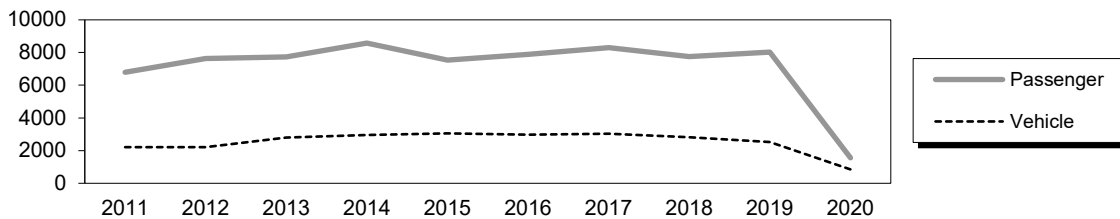
Summary of passenger and vehicle traffic volumes (source: <https://dot.alaska.gov/amhs/reports.shtml>):
